FAA-NA-77-41

FAA-RD-77-169

THE ANALYSIS OF NATIONAL TRANSPORTATION SAFETY BOARD
LARGE FIXED-WING AIRCRAFT ACCIDENT/INCIDENT REPORTS
FOR THE POTENTIAL PRESENCE OF LOW-LEVEL WIND SHEAR.

11
DECEMBER 1977

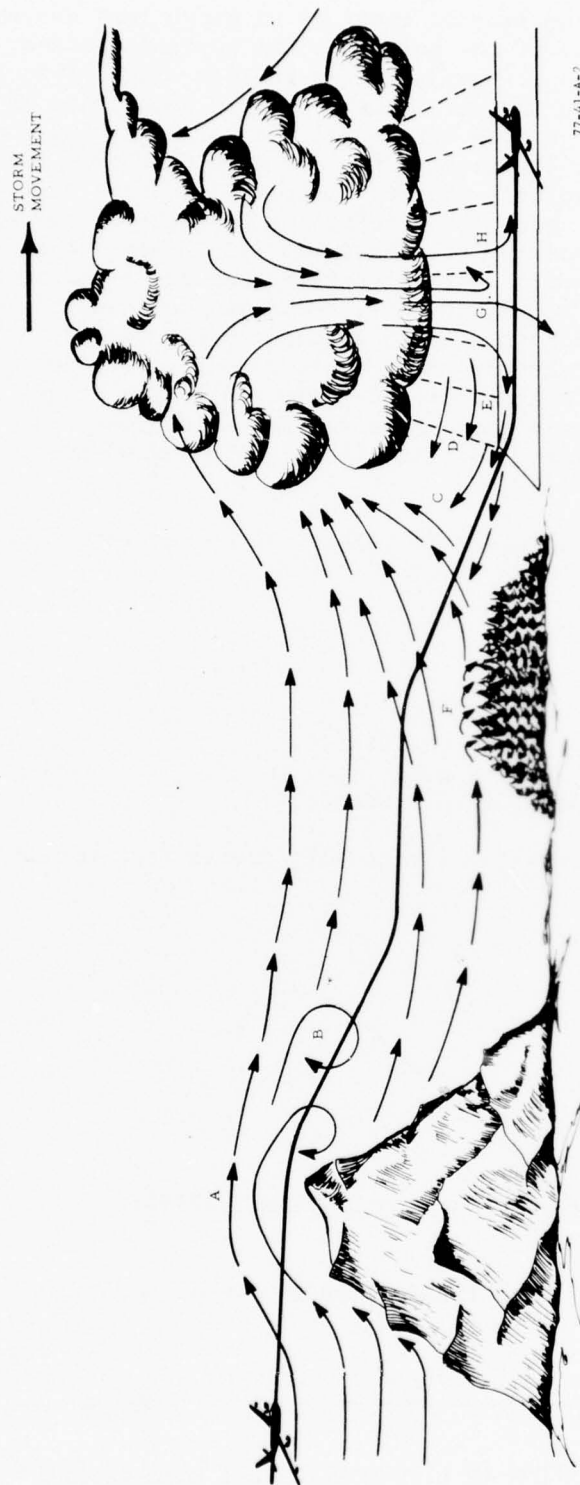
77-41-A-2

FIGURE A-3. WIND SHEAR DEFINITION WITH RESPECT TO EARTH REFERENCE

This definition would include as wind shears, those noted in the Boeing article, plus (1) updrafts and downdrafts, (2) mountain waves (topographic), and (3) shifts in windspeed and or direction due to surface characteristics and surrounding structures (orographic). Figure A-3 shows examples of this definition of wind shear.
